Effect of Variable Chord Length on Transonic Axial Rotor Performance Investigated

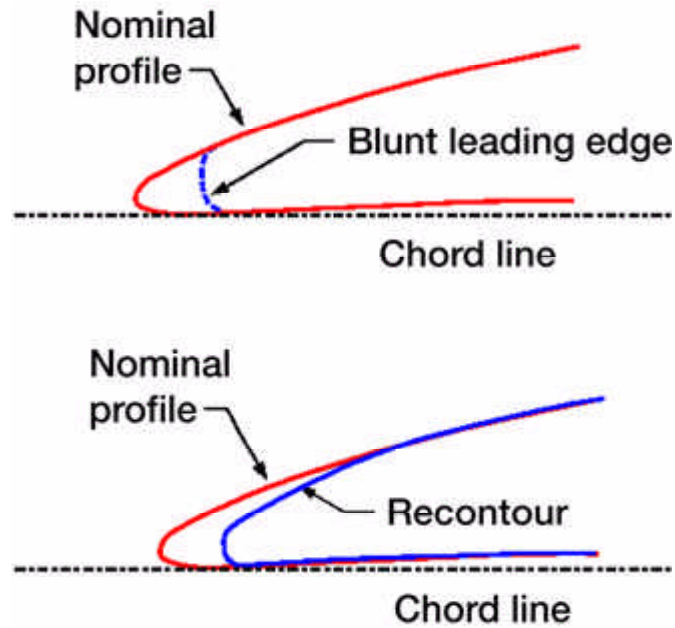
Blade leading edge. Top: Leading edge blunt because of erosion. Bottom: Recontoured leading edge.

During the life of any gas turbine, blade erosion is present, especially for those units that are exposed to unfiltered air, such as aviation turbofan engines. The effect of this erosion is to reduce the blade chord progressively from the midspan to the tip region and to roughen and distort the blade surface. The effects of roughness on rotor performance have been documented by Suder et al. (ref. 1) and Roberts (ref. 2). These papers indicate that the penalty for leading-edge roughness and erosion can be significant. Turbofan operators, therefore, restore chord length at routine maintenance intervals to regain performance before deterioration is too severe to salvage blades. As the rotor blades erode, the leading edge becomes rough--blunt and distorted from the nominal shape--and the aerodynamic performance suffers. Nominal performance can be recovered by recontouring the leading edges as illustrated in the figure to the right. This process, which inherently shortens the blade chord, can be used until the blade chord erodes to the stall limit. Below this chord length, which varies among engine-compressor types, a decrease of stall margin is likely.

After compressor blade rework that includes leading edge recontouring, the blades have different chord lengths, ranging from blades that are near nominal chord length down to those near the stall chord limit. Furthermore, as blades erode below the stall limit, they must be replaced with new blades that have the full nominal chord length. Consequently, a set of compressor blades with varying chord lengths will be installed into each turbofan engine that goes through a complete maintenance cycle. The question arises, "Does fan or compressor performance depend on the order in which mixed-chord blades are installed into a fan or compressor disk?"

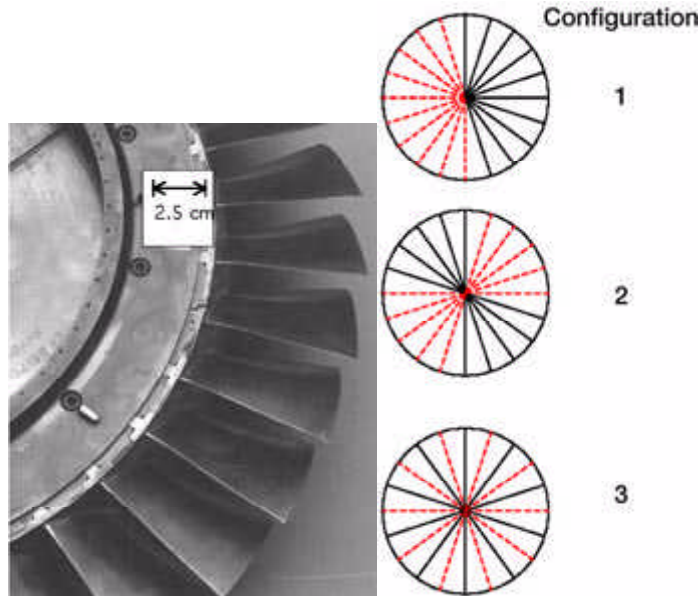
Left: Transonic compressor for NASA rotor35. Right: Tested blade configurations. (1) All long-chord blades grouped together; all short-chord blades grouped together. (2) Alternating quadrants of long- and short-chord blades. (3) Long- and short-chord blades alternating around the wheel.

To investigate this issue, the aerodynamic performance of a NASA transonic compressor rotor (shown in the photograph) operating with blades of varying chord length was measured in back-to-back compressor tests in NASA Glenn Research Center's W8 Transonic Compressor Facility. One half of the rotor blades were the full nominal chord length, and the remaining half of the blades were cut back at the leading edge to 95 percent of the chord length and recontoured. The rotor aerodynamic performance was measured at 100, 80, and 60 percent of the design speed for the blade installation configurations shown in the figure to the right: (1) nominal-chord blades in half of the disk and short-chord blades in half of the disk, (2) four alternating quadrants of nominal-chord and short-chord blades, and (3) nominal-chord and short-chord blades alternating around the disk.

The test results indicate only slight differences in performance with the "alternating" blade installation configuration at specific operating conditions, which are documented and discussed further in reference 3. Otherwise, there was no significant difference in performance among the various blade configurations. Since the three installation configurations tested cover the extremes of possible chord mismatch, it can be concluded that chord mismatching is not important to aerodynamic performance above the stall chord limit, which for most civil aviation engines is between 94 and 96 percent of nominal (new) chord length. This statement applies *only* to blades that have been refurbished with a leading edge recontour.
